Light Water Reactor Sustainability Constellation Pilot Project FY12 Summary Report

R. Johansen

September 2012

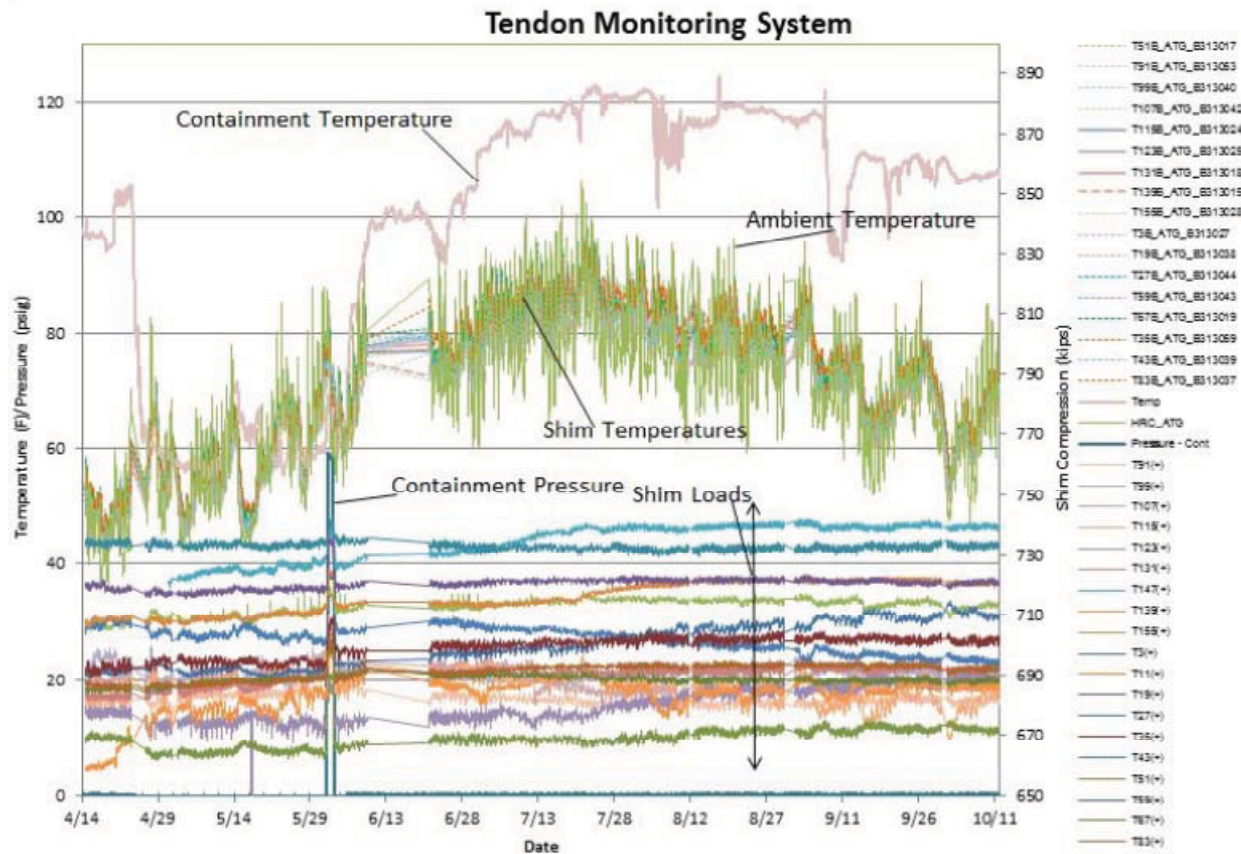
Figure 1. Tendon data from 4/14/11 to 10/12/11.

In FY10, Twenty of the vertical tendons and one exposed circumferential rebar were outfitted with a fiber optic strain gauges (Figures 1 and 2) connected to a Data Acquisition System (DAS) to monitor temperature and strain of the containment wall and tendons. Tendon strain gage data has been collected except for the period from 4/14/11 to 10/12/11 and from 2/28/12 to 5/8/12. The data gap resulted from a power disruption which exceeded the capability of the UPS. The data indicates that the tendon load is not significantly affected by shim temperature since the lines are relatively flat except for the SIT (pressure test) performed in early June 2011.

Additional information on the Ginna tendon monitoring system and results are in Reference 2.

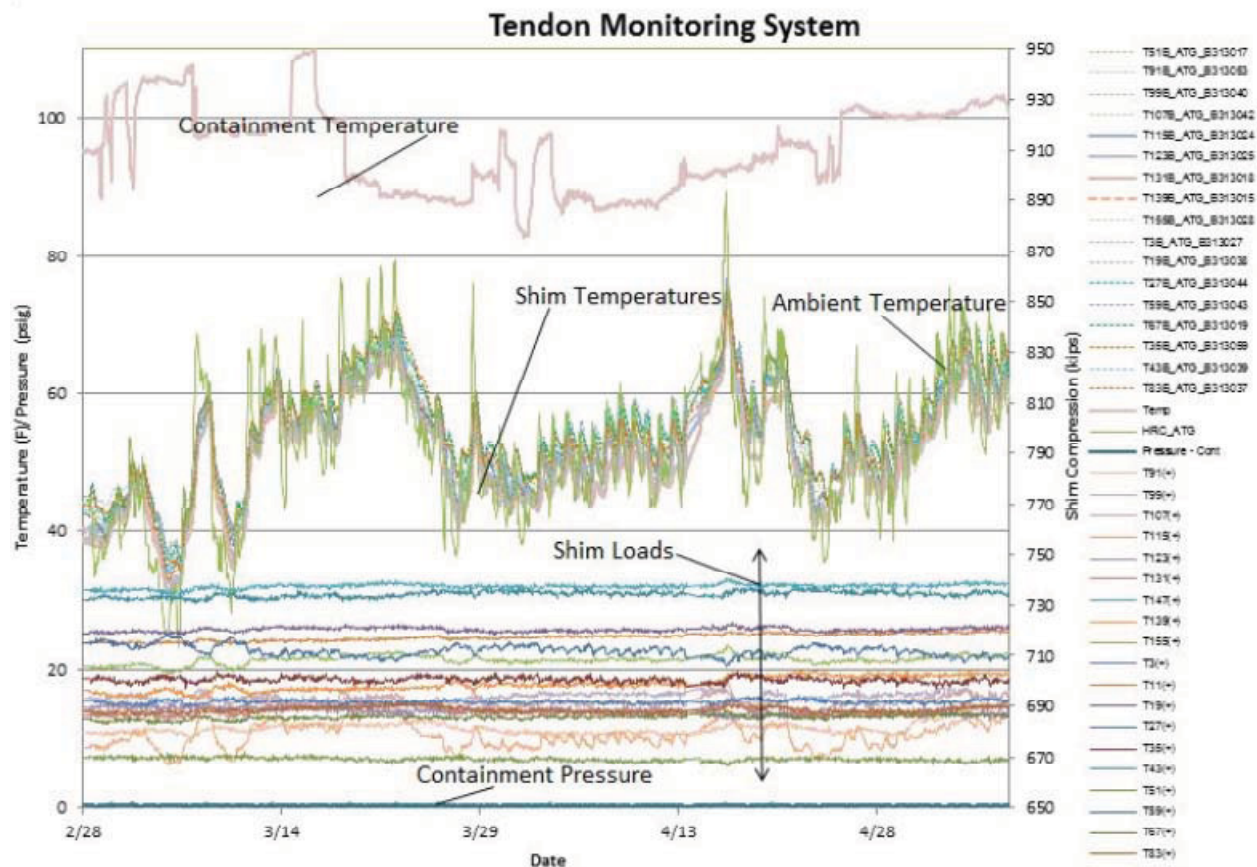
Figure 2. Tendon data from 2/28/12 to 5/8/12.

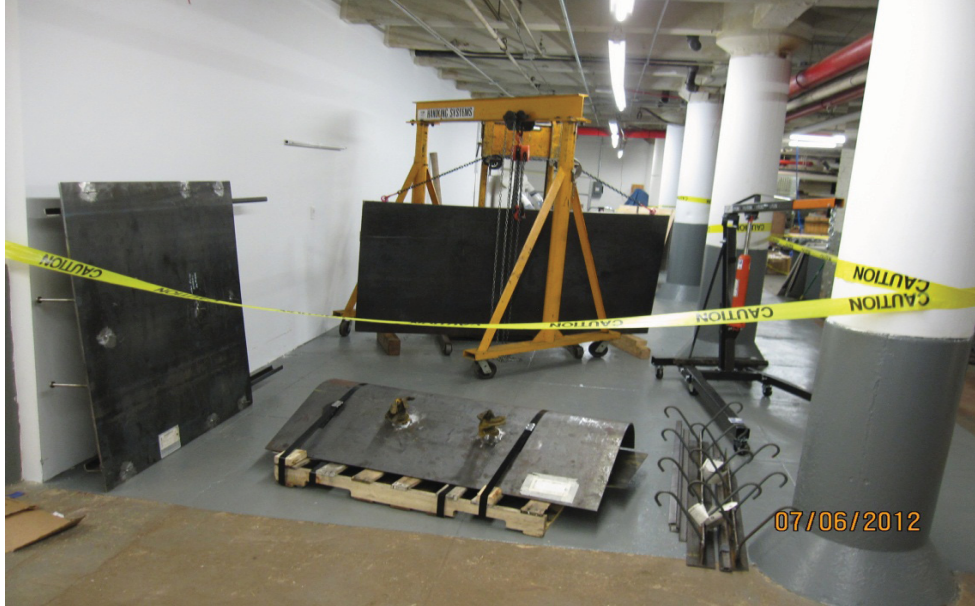
Figure 3. Fabrication of containment mockups.

Mockups of the Ginna and NMP1 containment structures were fabricated in FY12. See Figures 3 and 4. The concrete mockups simulate of the containment susceptible to corrosion. The mockups are used for testing guided wave and T-SAFT non-destruction contamination techniques for detection degradation of the containment liner. The liners have been fabricated and tested without flaws and with flaws prior to placement of the final concrete. The necessary concrete cure duration will be complete the end of October 2012. Once the concrete has cured, testing is scheduled to resume. The testing will indicate the extent of detection for various flaw sizes in a containment structure. The flaws are located in both accessible an inaccessible regions of the structure.
